## APPENDIX C2 – MEANDER BELT ANALYSIS

DATE: November 28<sup>th</sup> 2008

SUBJECT: Highland Creek Meander Belt Width Assessment – Morningside Avenue

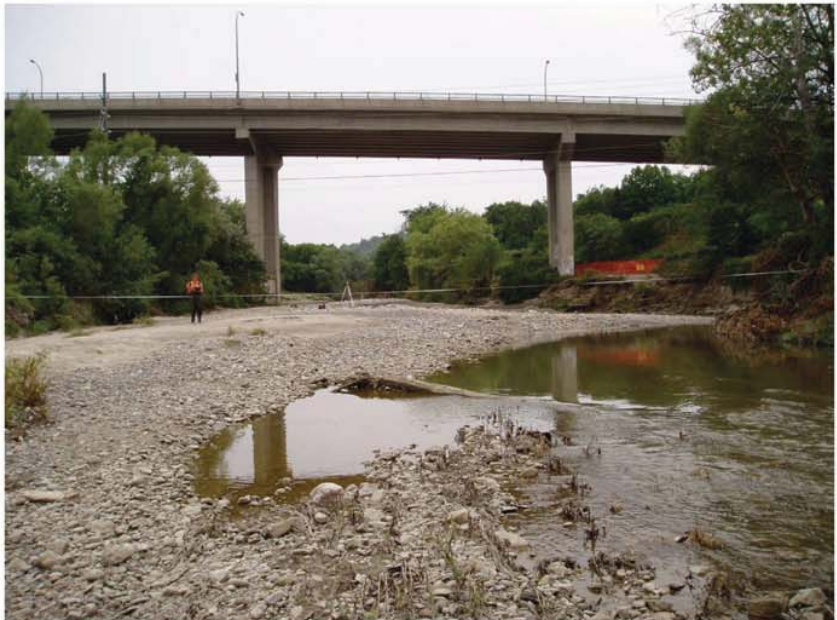
Subsequent to the establishment of this monitoring site, High flows associated with the August 19<sup>th</sup> storm event of 2005 resulted in significant erosion and adjustments in channel planform along several sections of Highland Creek, including the portion of channel in vicinity of Morningside Avenue. This adjustment resulted in the exposure of a bridge pier footing, watermain and Bell Canada conduit at the site (**Photos 1-3**). In response to these issues, the City of Toronto retained PARISH Geomorphic Ltd. to develop a design to mitigate these issues as part of an Emergency Works project. In 2007, a design was completed for these emergency works on Highland Creek. As part of the field work in support of this design, the creek was re-surveyed in 2007. **Figure 4** illustrates the location of the channel thalweg location in 2003 and 2007, illustrating the dynamic nature of Highland Creek at this site. **Figure 5**, meanwhile, illustrates the recommended design solution in which the active channel was enlarged to increase channel capacity, and a series of riffles were constructed to act as grade control and train flows to ensure a central thalweg and protect existing infrastructure. While initial design alternatives did consider a complete channel realignment within this section of Highland Creek to increase meander amplitude and stream length, this option was considered inappropriate due to factors such as cost and constructability. Construction of the preferred design alternative is currently on-going.

**Photo 1.** Looking downstream at Morningside Avenue (post August 19<sup>th</sup>).

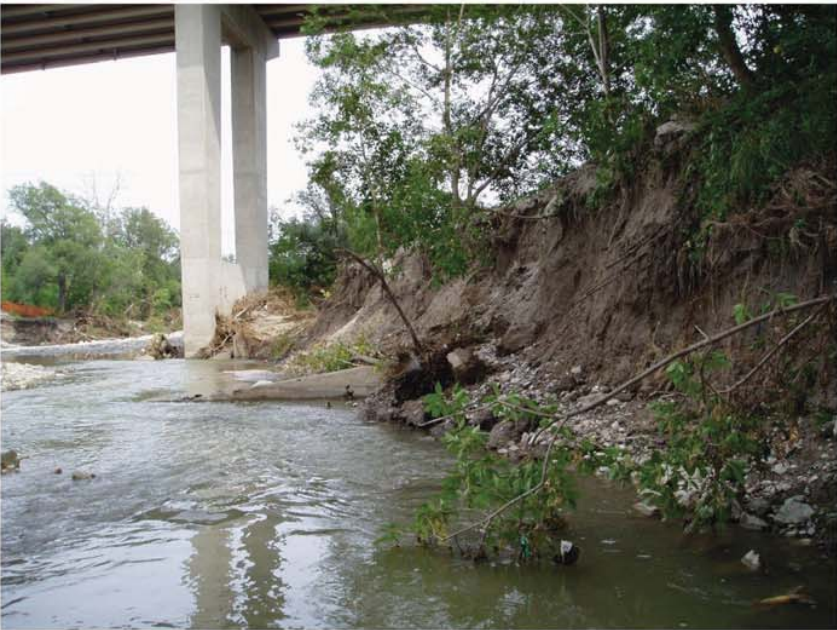
**Photo 2.** Exposed bridge pier and eroded bank.

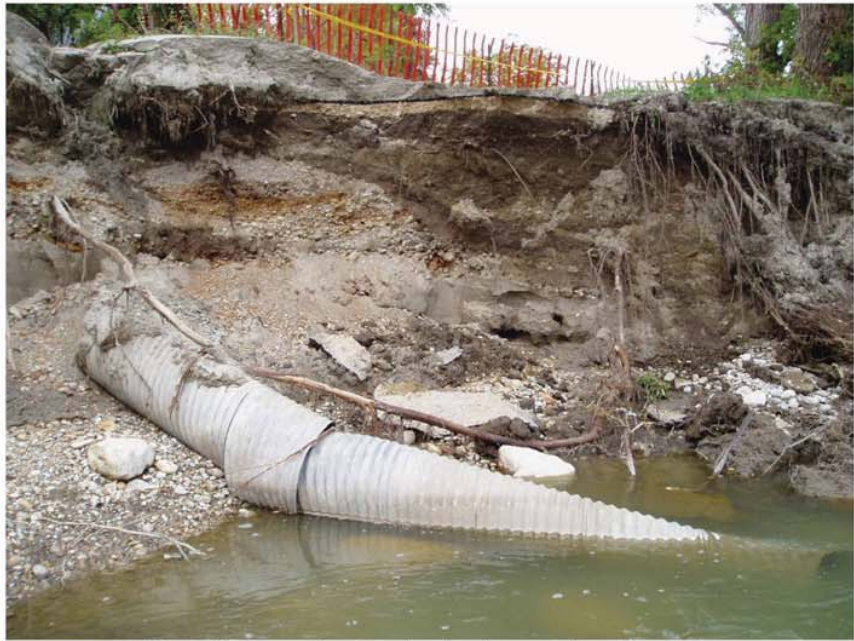
Photo 3. Exposed and undermined watermain and conduit.

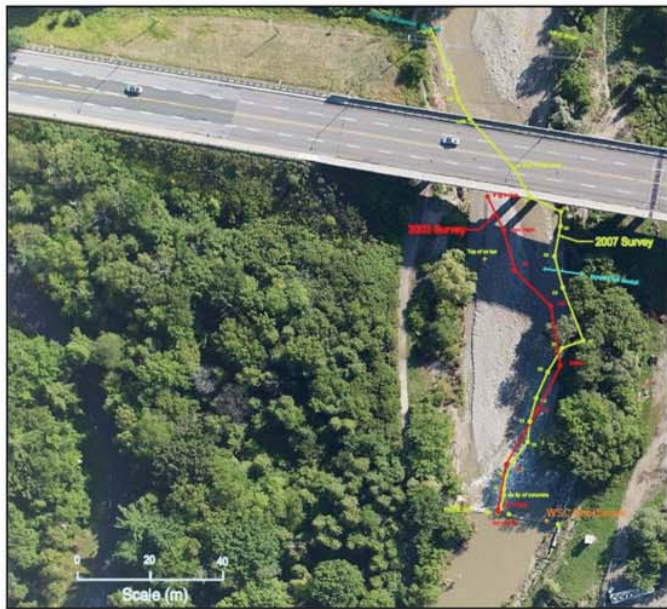
Figure 4. 2003 and 2007 survey showing the change in thalweg location near Morningside Avenue.

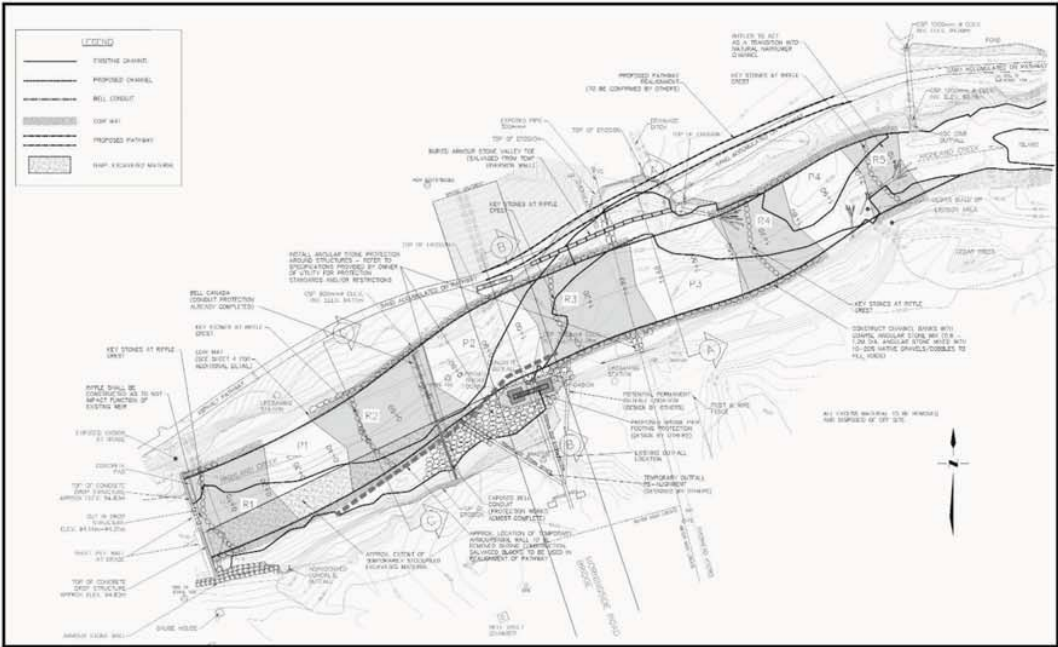
Figure 5. Recommended design solution currently being implemented at Morningside Ave.

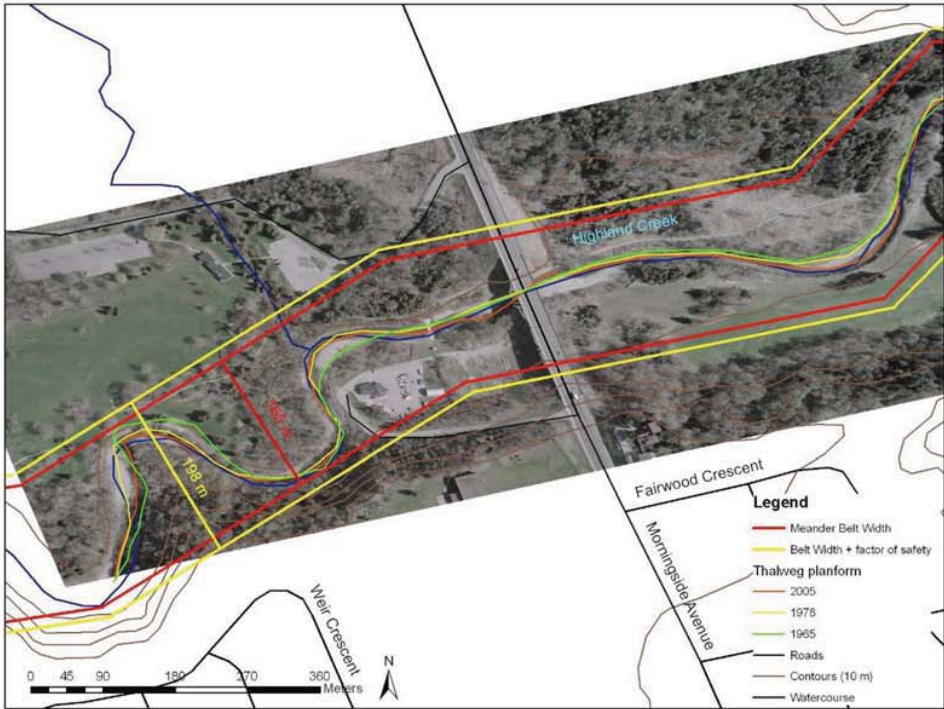
The meander belt width was delineated follow protocols outlined in the *Belt Width Delineation Procedures* (PARISH Geomorphic Ltd., 2004). The meander axis was first determined by following the general down-valley orientation of the meander pattern. Following the identification of the meander axis, the preliminary belt width was determined by drawing parallel lines tangential to the outside defining meanders of the planform. Given the dynamic nature of the creek, historic planform information was also taking into consideration in determining the belt width. Based on this approach, the preliminary belt width for Highland Creek at Morningside Avenue was determined to be 165 meters.

To account for any future migration, a factor of safety was applied to the meander belt width. Where possible, the 100 year migration rate is used when it can be calculated from the meanders defining the belt width. In this case, the 100 year migration rate of 16 m was primarily driven by measurements taken from meanders which did not define the belt width. Therefore, the 100-year migration rate was compared against a generic 20% factor of safety (10% to be applied on either side of the belt width) that can also be applied in lieu of migration rate analysis (PARISH Geomorphic Ltd., 2004). This resulted in a setback of 16.5 m which was equivalent to the quantified migration rates, and a final belt width of 198 m. **Figure 7** shows the meander belt width plus factor of safety in addition to the planform overlay determined from the 2005, 1978 and 1965 aerial photographs.

**Figure 7.** Meander belt width delineation for Highland Creek at the crossing of Morningside Ave.

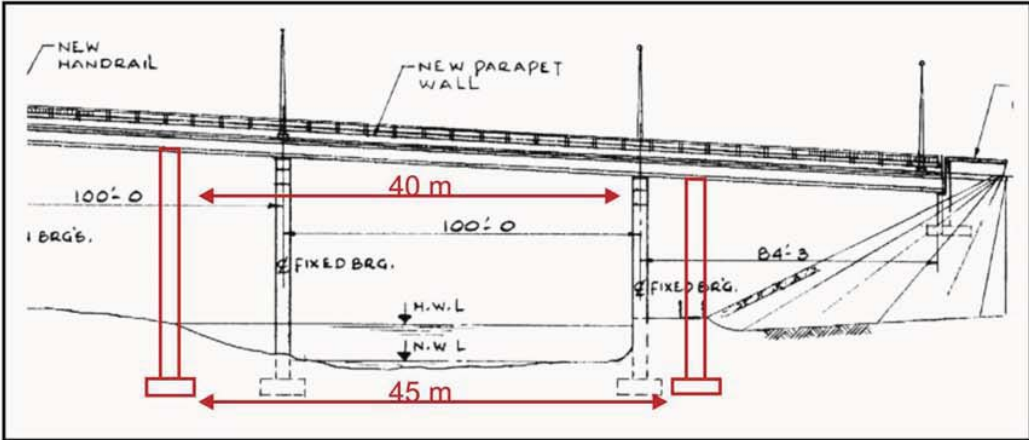
While, in a defined valley system, the meander belt width is generally considered the optimum span for a stream road crossing, it is also recognized that this type of structure is often cost prohibitive. Upon reviewing the existing structural drawings and in consideration of the optimal location of the crossing relative to channel planform, the current span of 120 m can be considered an appropriate dimension. Of greater interest is the location and span between bridge piers. As illustrated in **Figure 8**, the first and second piers along the north abutment were not placed outside of the high water level of Highland Creek.

**Figure 8.** Existing and proposed Morningside Avenue bridge pier locations.

Therefore, it is recommended that the current crossing location and span could be maintained, however the distance between the piers should be increased to allow for some natural adjustment of the channel while minimizing the risk to infrastructure. Currently, the bridge piers are 30.48 m apart, however a span of approximately 40-45 meters would allow the piers to span the high water level and most active section of channel within the valley floor. Conversely, if a new crossing were proposed, the 120 m span would likely be sufficient, but would be centered on the channel with pier spans of 40-45 m. Both options maintain the existing 90 degree road alignment to the creek at a fairly straight riffle section. As has been demonstrated, Highland Creek is a highly dynamic system.

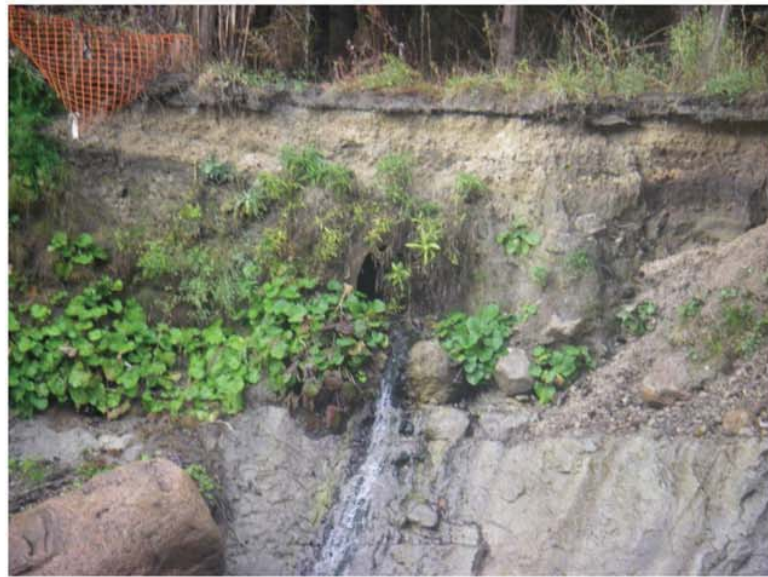
**Photo 1.** Elevated storm sewer outlet and erosion downstream of the pedestrian bridge.

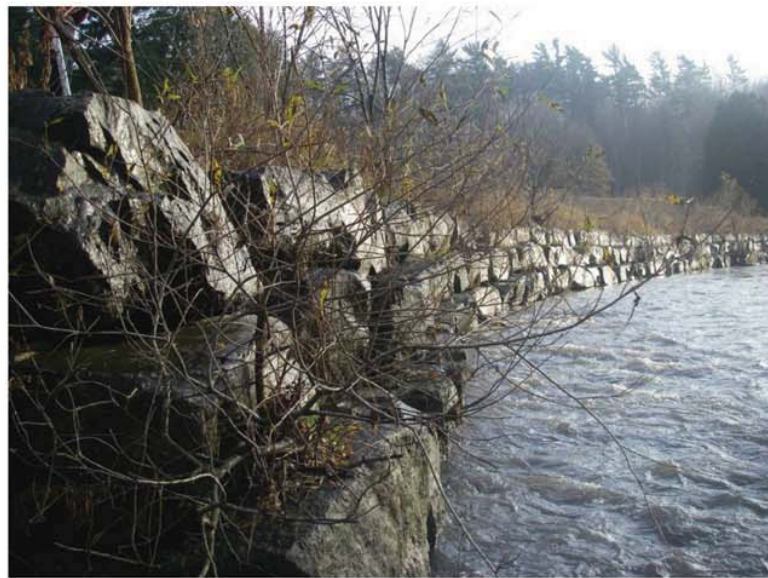
**Photo 2.** Armour stone wall downstream of Morningside Avenue.

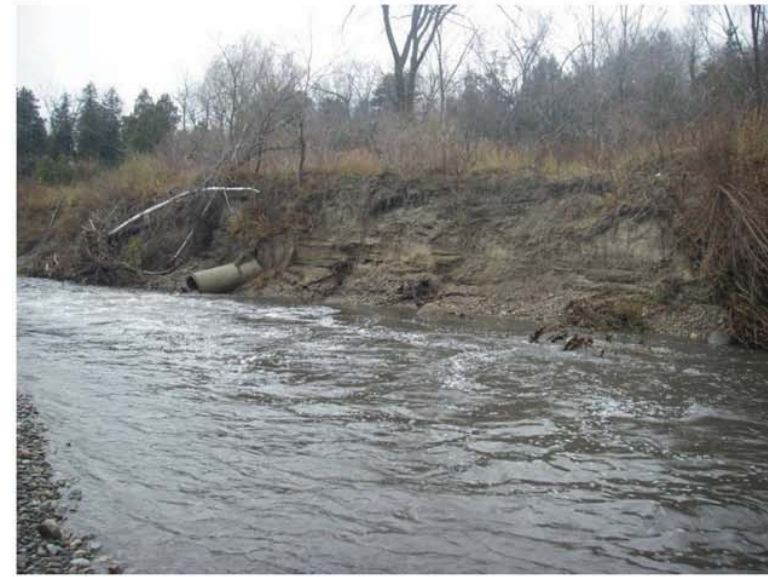
**Photo 3.** Bank erosion and exposed concrete pipe downstream of Morningside Avenue.

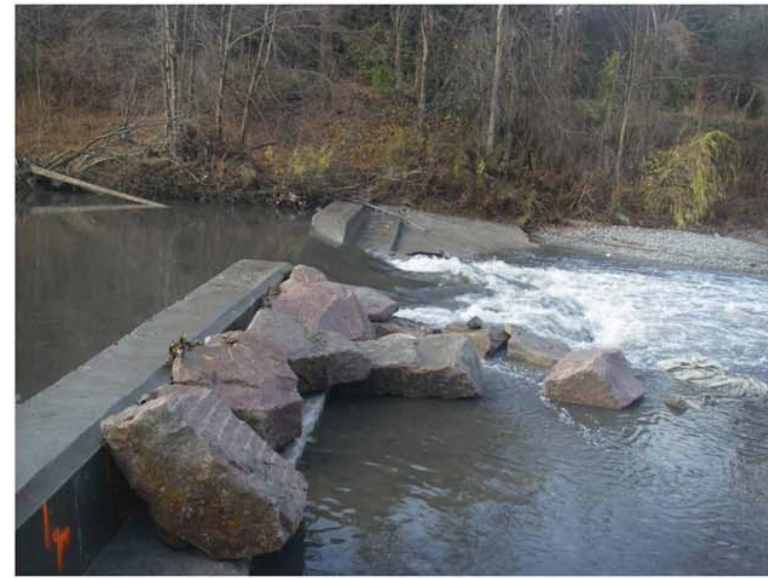
**Photo 4.** The weir upstream of Morningside Avenue.

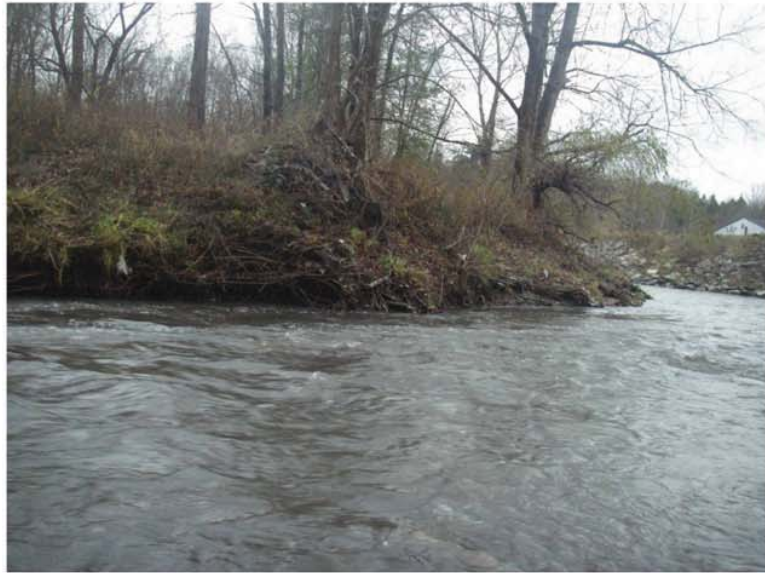
**Photo 5.** Toe erosion on the inside meander bend upstream of the weir.

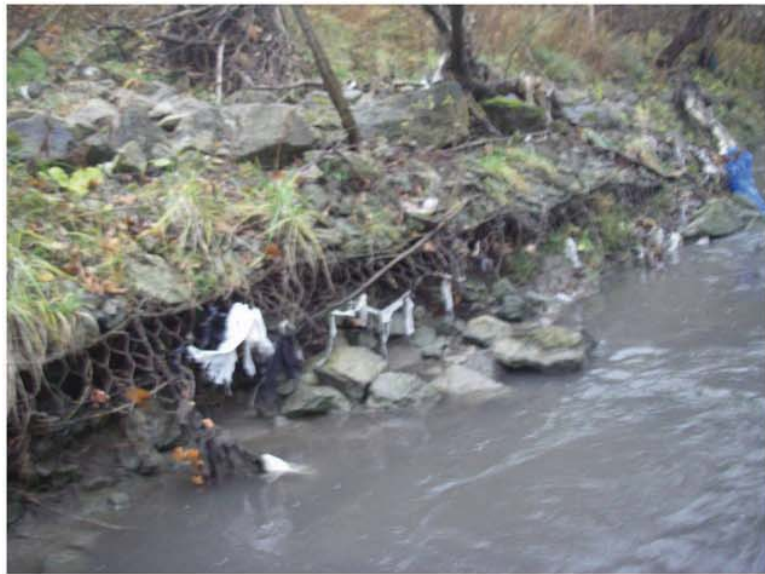
**Photo 6.** Failed gabion baskets upstream of Morningside Avenue.

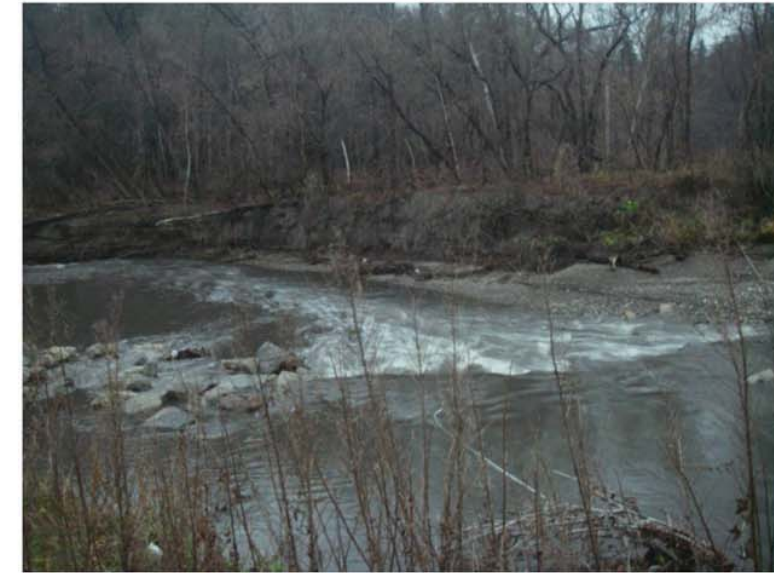
**Photo 7.** Looking downstream at a riffle towards erosion on the south bank.
