**Cultural Heritage Assessment Report:
Built Heritage Resources and Cultural Heritage Landscapes**

**Scarborough – Malvern Light Rail Transit Corridor
Transit Project Assessment Study
City of Toronto, Ontario**

ASI File 08EA-104

March 2009 (Revised September 2009; October 2009)

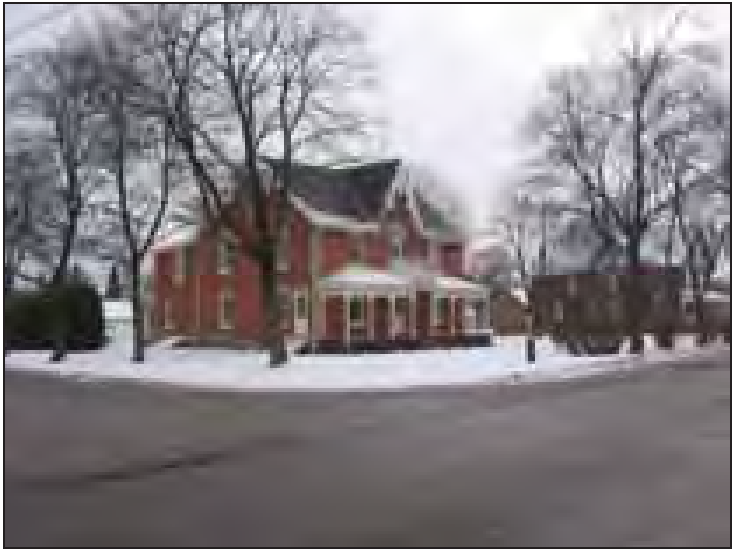
| Built Heritage Resource: | BHR 1 |

| Location: | 27 Old Kingston Road |
| Description: | This 2 ½ store house features a brick exterior on a stone foundation. This residence is set in a classic, Ontario Gothic-Revival inspired farmhouse design. Its central gable, decorative bargeboard, hood mouldings, and detailed veranda that spans the full front façade are typical design elements of this style. |
| Comments: | Known as the John-Richardson House, Designated under the <i>Ontario Heritage Act</i> , By-Law 18852 |

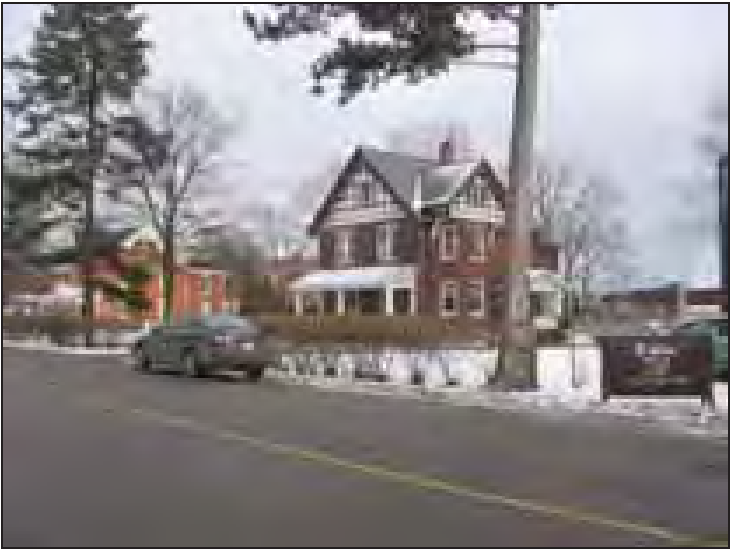
| Built Heritage Resource: | BHR 2 |

| Location: | 21 Old Kingston Road |
| Description: | This 2 ½ storey residence features a brick exterior, half timbering, and a cross-gable roof-line. Based on its architectural detailing, it is likely that this structure was constructed in the earlier 20 th century. A smaller, brick outbuilding is situated on the southern elevation of the property and in close proximity to the road right-of-way. |
| Comments: | Known as the Richard-Corson House; Designated under the <i>Ontario Heritage Act</i> , By-Law 19474 |

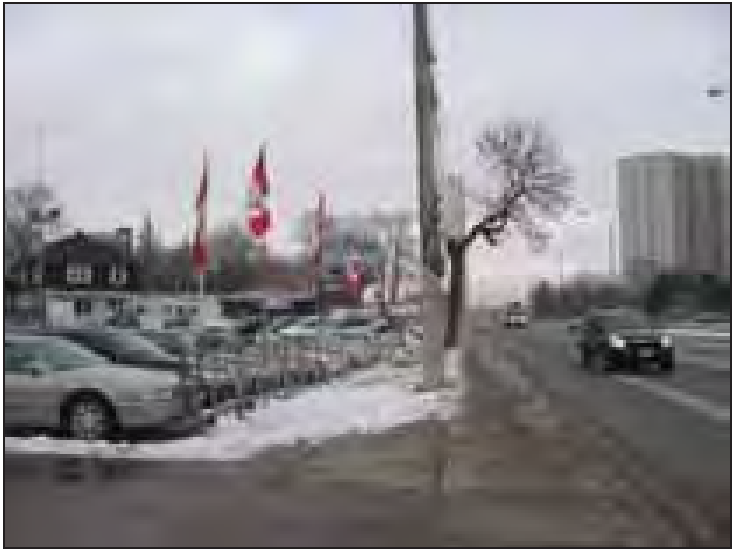
Built Heritage Resource: BHR 3

Location: 4234 Kingston Road

Description: This structure is set back from the current road right-of-way and features clapboard siding, a hipped roof, and internal brick chimney. It is likely that this structure dates to the earlier 20th century.

Comments: Identified during the field review.

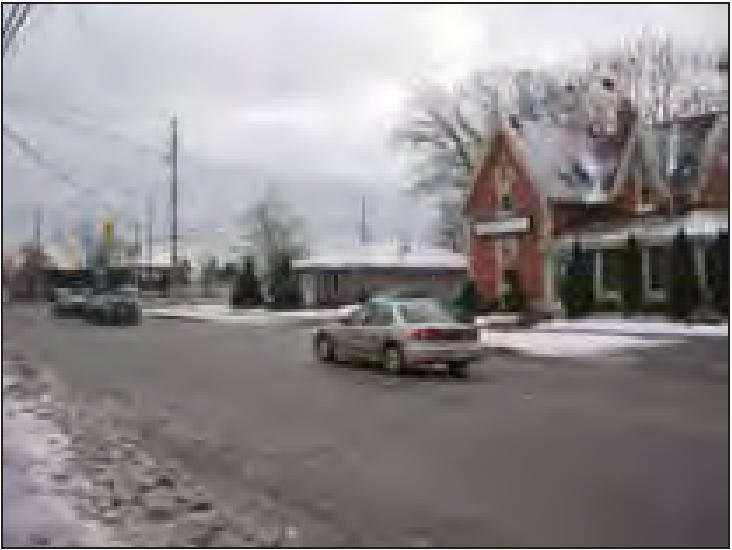
Built Heritage Resource: BHR 4

Location: 156 Galloway Road

Description: This 1 ½ storey residence dates to the mid to late 19th century and is modelled in the Classic, Ontario Gothic-Revival inspired farmhouse design. Its centre gabled, wrap-around veranda, buff brick work, and decorative bargeboard are typical design elements of this style.

Comments: Known as the Richard Eade House; Designated under the *Ontario Heritage Act*, By-Law 20972

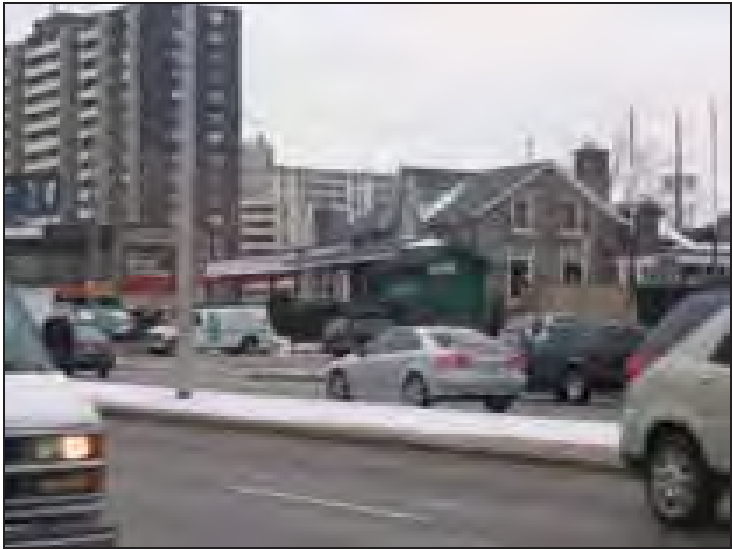
Built Heritage Resource: BHR 5

Location: 3750 Kingston Road

Description: This 1 ½ storey house features a stone exterior on a likely stone foundation. Its central gable, symmetrical façade, and stone exterior indicate that it was likely built in the mid 19th century.

Comments: Jeremiah Annis House; Designated under the *Ontario Heritage Act*, By-Law 18102.

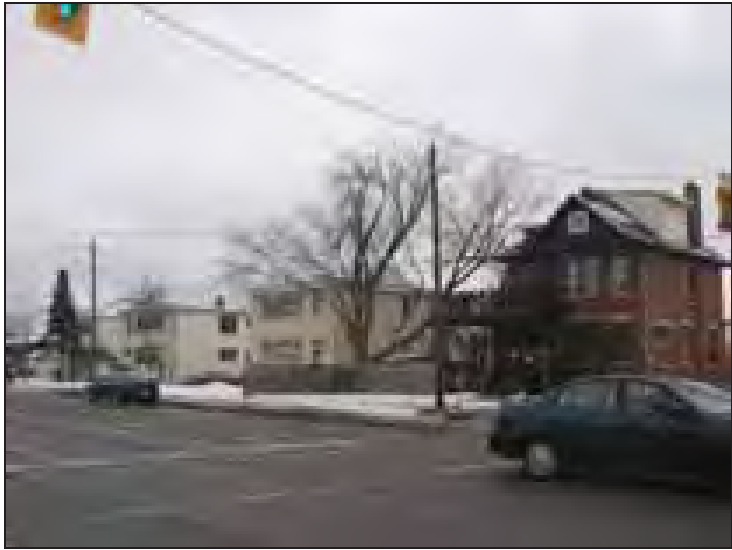
Built Heritage Resource: BHR 6

Location: 344 Morningside Avenue

Description: This 2 ½ storey residence features a brick exterior on an unknown foundation. Its massing, front-facing gable roof line, and use of a turret-design suggest that it was built in the early 20th century. Although some additions have been made on the front and side, its original design elements and massing are still clearly visible.

Comments: Identified during the field review.

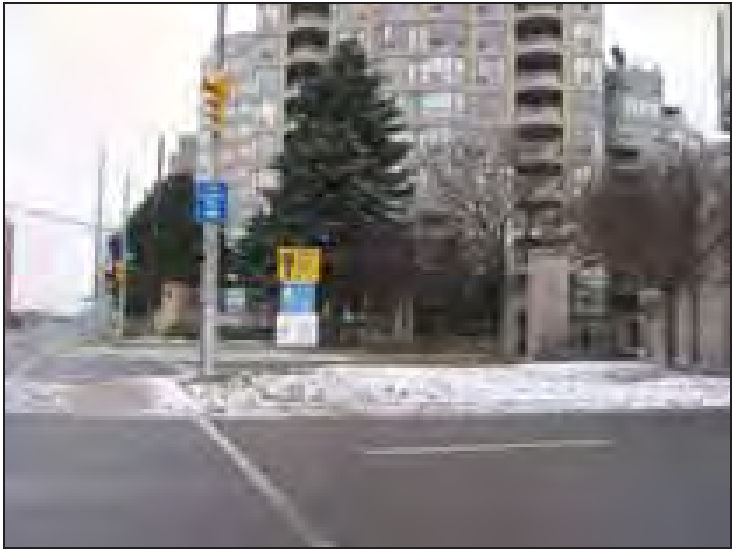
| Built Heritage Resource: | BHR 7 |

| Location: | Corner of Guildwood Parkway and Kingston Road. |
| Description: | At the corner of the Guildwood Parkway and Kingston Road, an entrance way to this cultural landscape stands, composed of stone and wrought-iron materials. A 1957 datestone is etched on to this entrance way. Research suggests that these gates were originally located at the Stanley Barracks. |
| Comments: | Identified during the field review. |

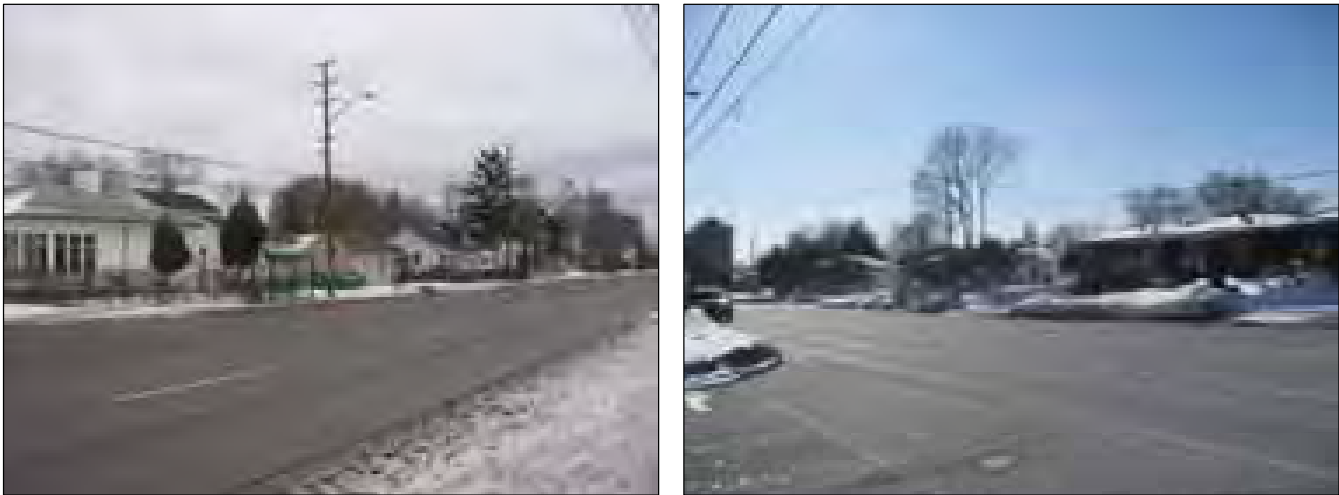
Cultural Heritage Landscape: CHL 2

Description: This post-war streetscape lines the east and west sides of Morningside Avenue, from Teft Road to Fairwood Crescent. Structures in this location are indicative of post-war residential design and contribute to the surrounding character of the area. The east side of the road retains a number of houses that reflect a good degree of scenic amenity and contribute to the streetscape, by virtue of well-proportioned massing, harmonized set-backs and incorporation of different, but complimentary, floor plans, roof-designs, and exterior materials.

Comments: Identified during the field review.

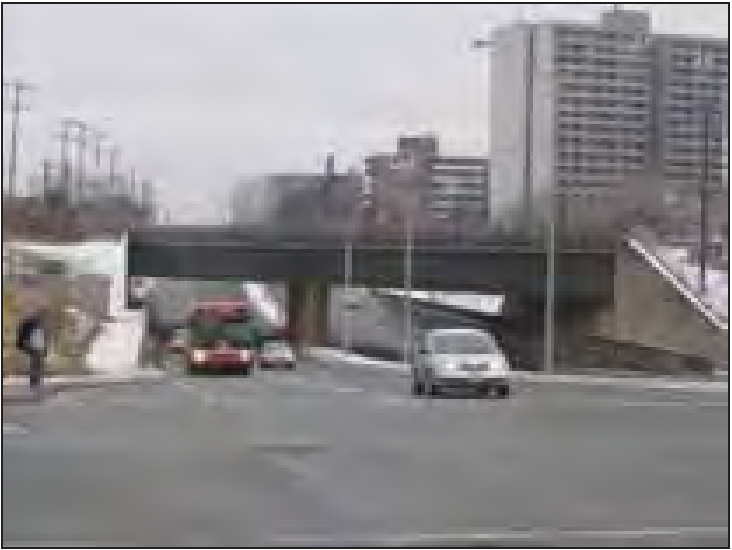
Cultural Heritage Landscape: CHL 3

Description: Passes over Eglinton Avenue, east of Cedar Brae Boulevard. The first of these tracks were laid in 1856 by the Grand Trunk Railway company, connecting Toronto to the towns to the east along the northern shore of Lake Ontario. The second track was laid to the north of the first one by the Grand Trunk Railway. The portion connecting Scarborough Junction to Toronto was constructed between 1884 and 1887. The portion connecting Scarborough Junction to the towns to the east was built in 1892.

Comments: Identified through historic mapping/field review.

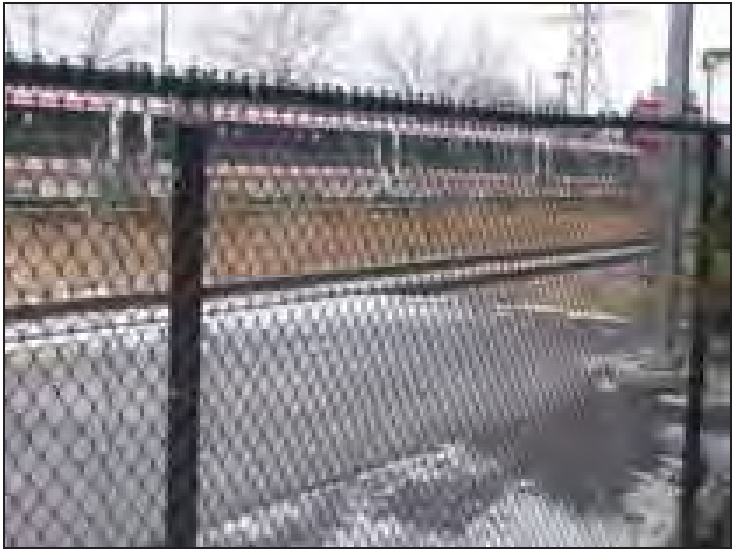
| Cultural Heritage Landscape: | CHL 4 |

| Description: | Passes over Eglinton Avenue, in a north-south direction, just west of Midland Avenue. The single track of this rail line was originally laid in 1871 by the Grand Trunk Railway, connecting Scarborough Junction with Stouffville. In the 1878 Atlas, it is known as the Toronto Nipissing Railway. |
