Existing and Future Conditions

3 EXISTING AND FUTURE CONDITIONS

**SCARBOROUGH RAPID TRANSIT
ENVIRONMENTAL PROJECT REPORT
CHAPTER 3 – EXISTING AND FUTURE CONDITIONS**

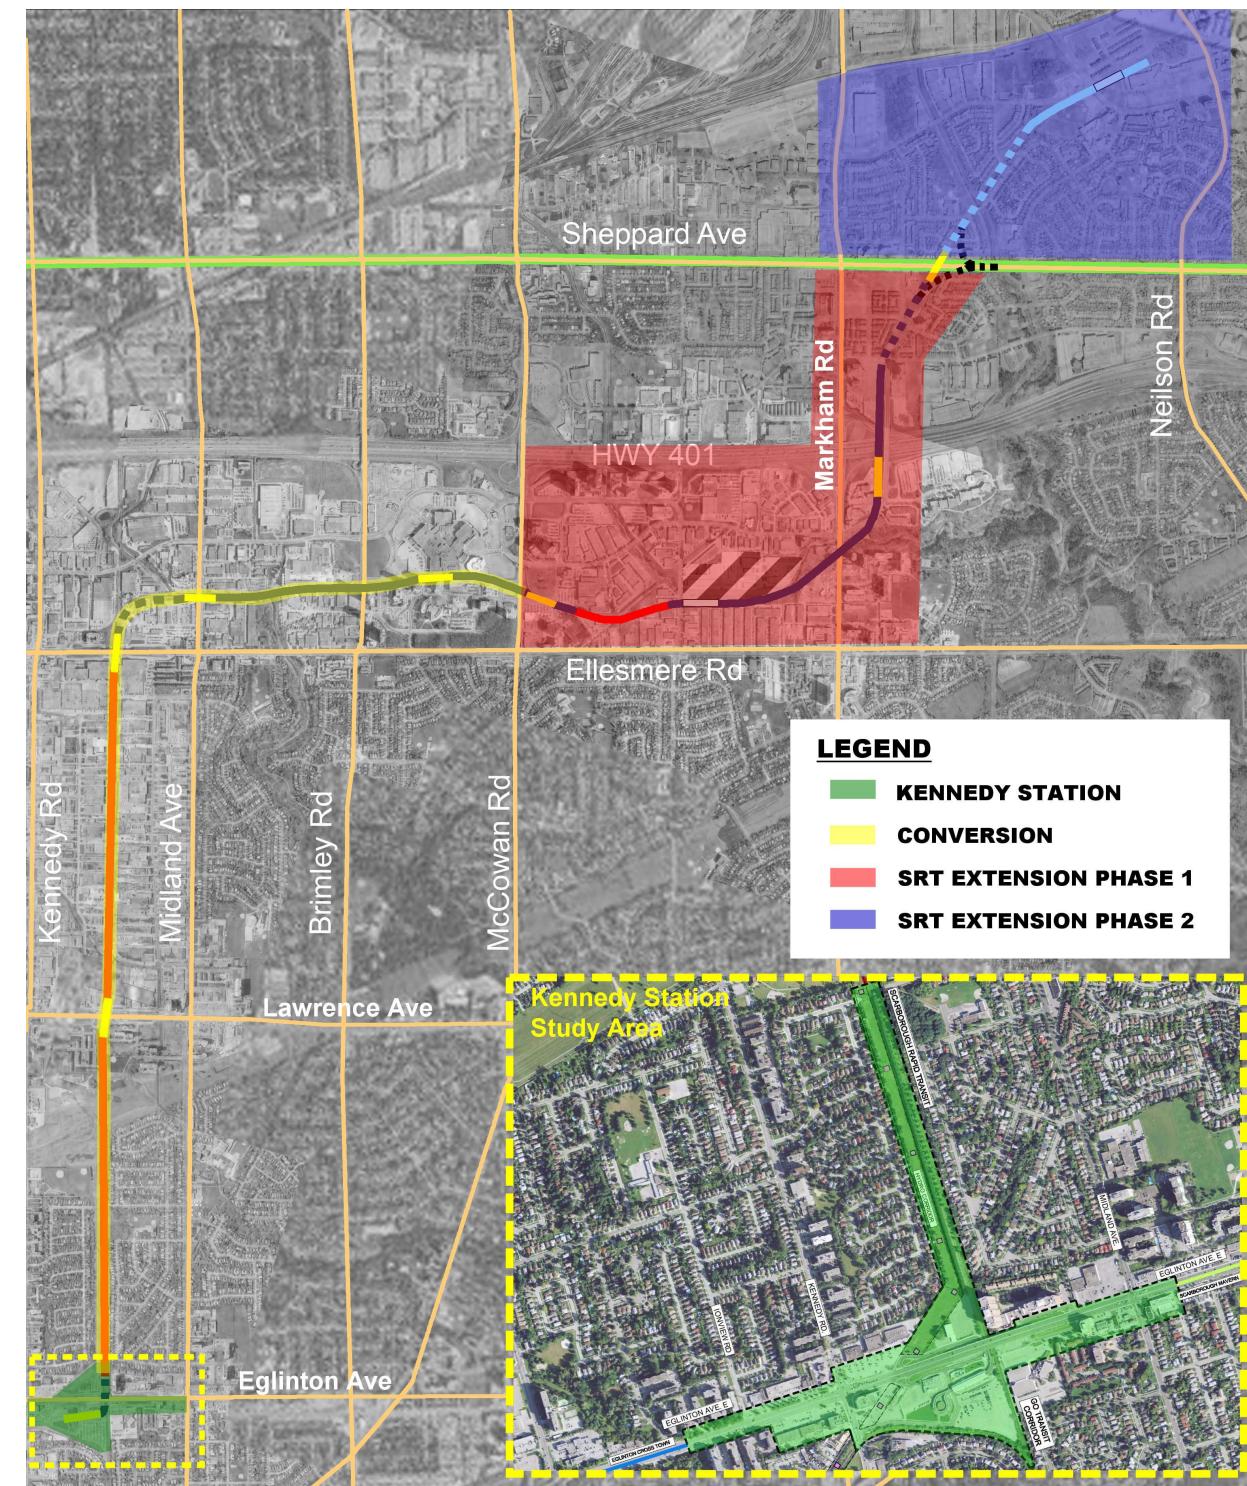
Exhibit 3-1: Study Area

Each section is then separated into existing and future conditions sections which discuss each of the environmental features mentioned above in a more detailed manner. The study area for this Transit Project Assessment consists of three major zones for each of the project components. As illustrated in Exhibit 3-1, the study limits for each section are as follows:

This includes the existing Kennedy Station site, plus Eglinton Avenue from west of Ionview Road in the west to east of Midland Avenue in the east. The study area also extends north in the GO Stouffville / SRT / Hydro One Networks Inc. corridors approximately 1km north of Eglinton Avenue.

The conversion component is limited to retrofit works on the existing line with the emphasis on changes at each of the existing stations, namely Lawrence East, Ellesmere, Midland, Scarborough Centre Station and McCowan Station. Based on the scope of works as identified in Chapter 2, the intent of the transit project within this section is to modify and upgrade the facility only as required. Modification of the stations is required due to the change in vehicle technology. Assessment of existing and future conditions was undertaken within a very narrow band that follows the existing SRT as the conversion works rarely extend beyond the footprint of the existing facility.

For the extension, the study area covers the area bounded by McCowan Road, Ellesmere Road, Neilson Road, the CP Agincourt subdivision, Markham Road and Highway 401. As preliminary planning activities were considering an extension to Malvern (i.e. not developed in stages), the inventory work described in this chapter and contained in the associated appendices address a consolidated extension study area.

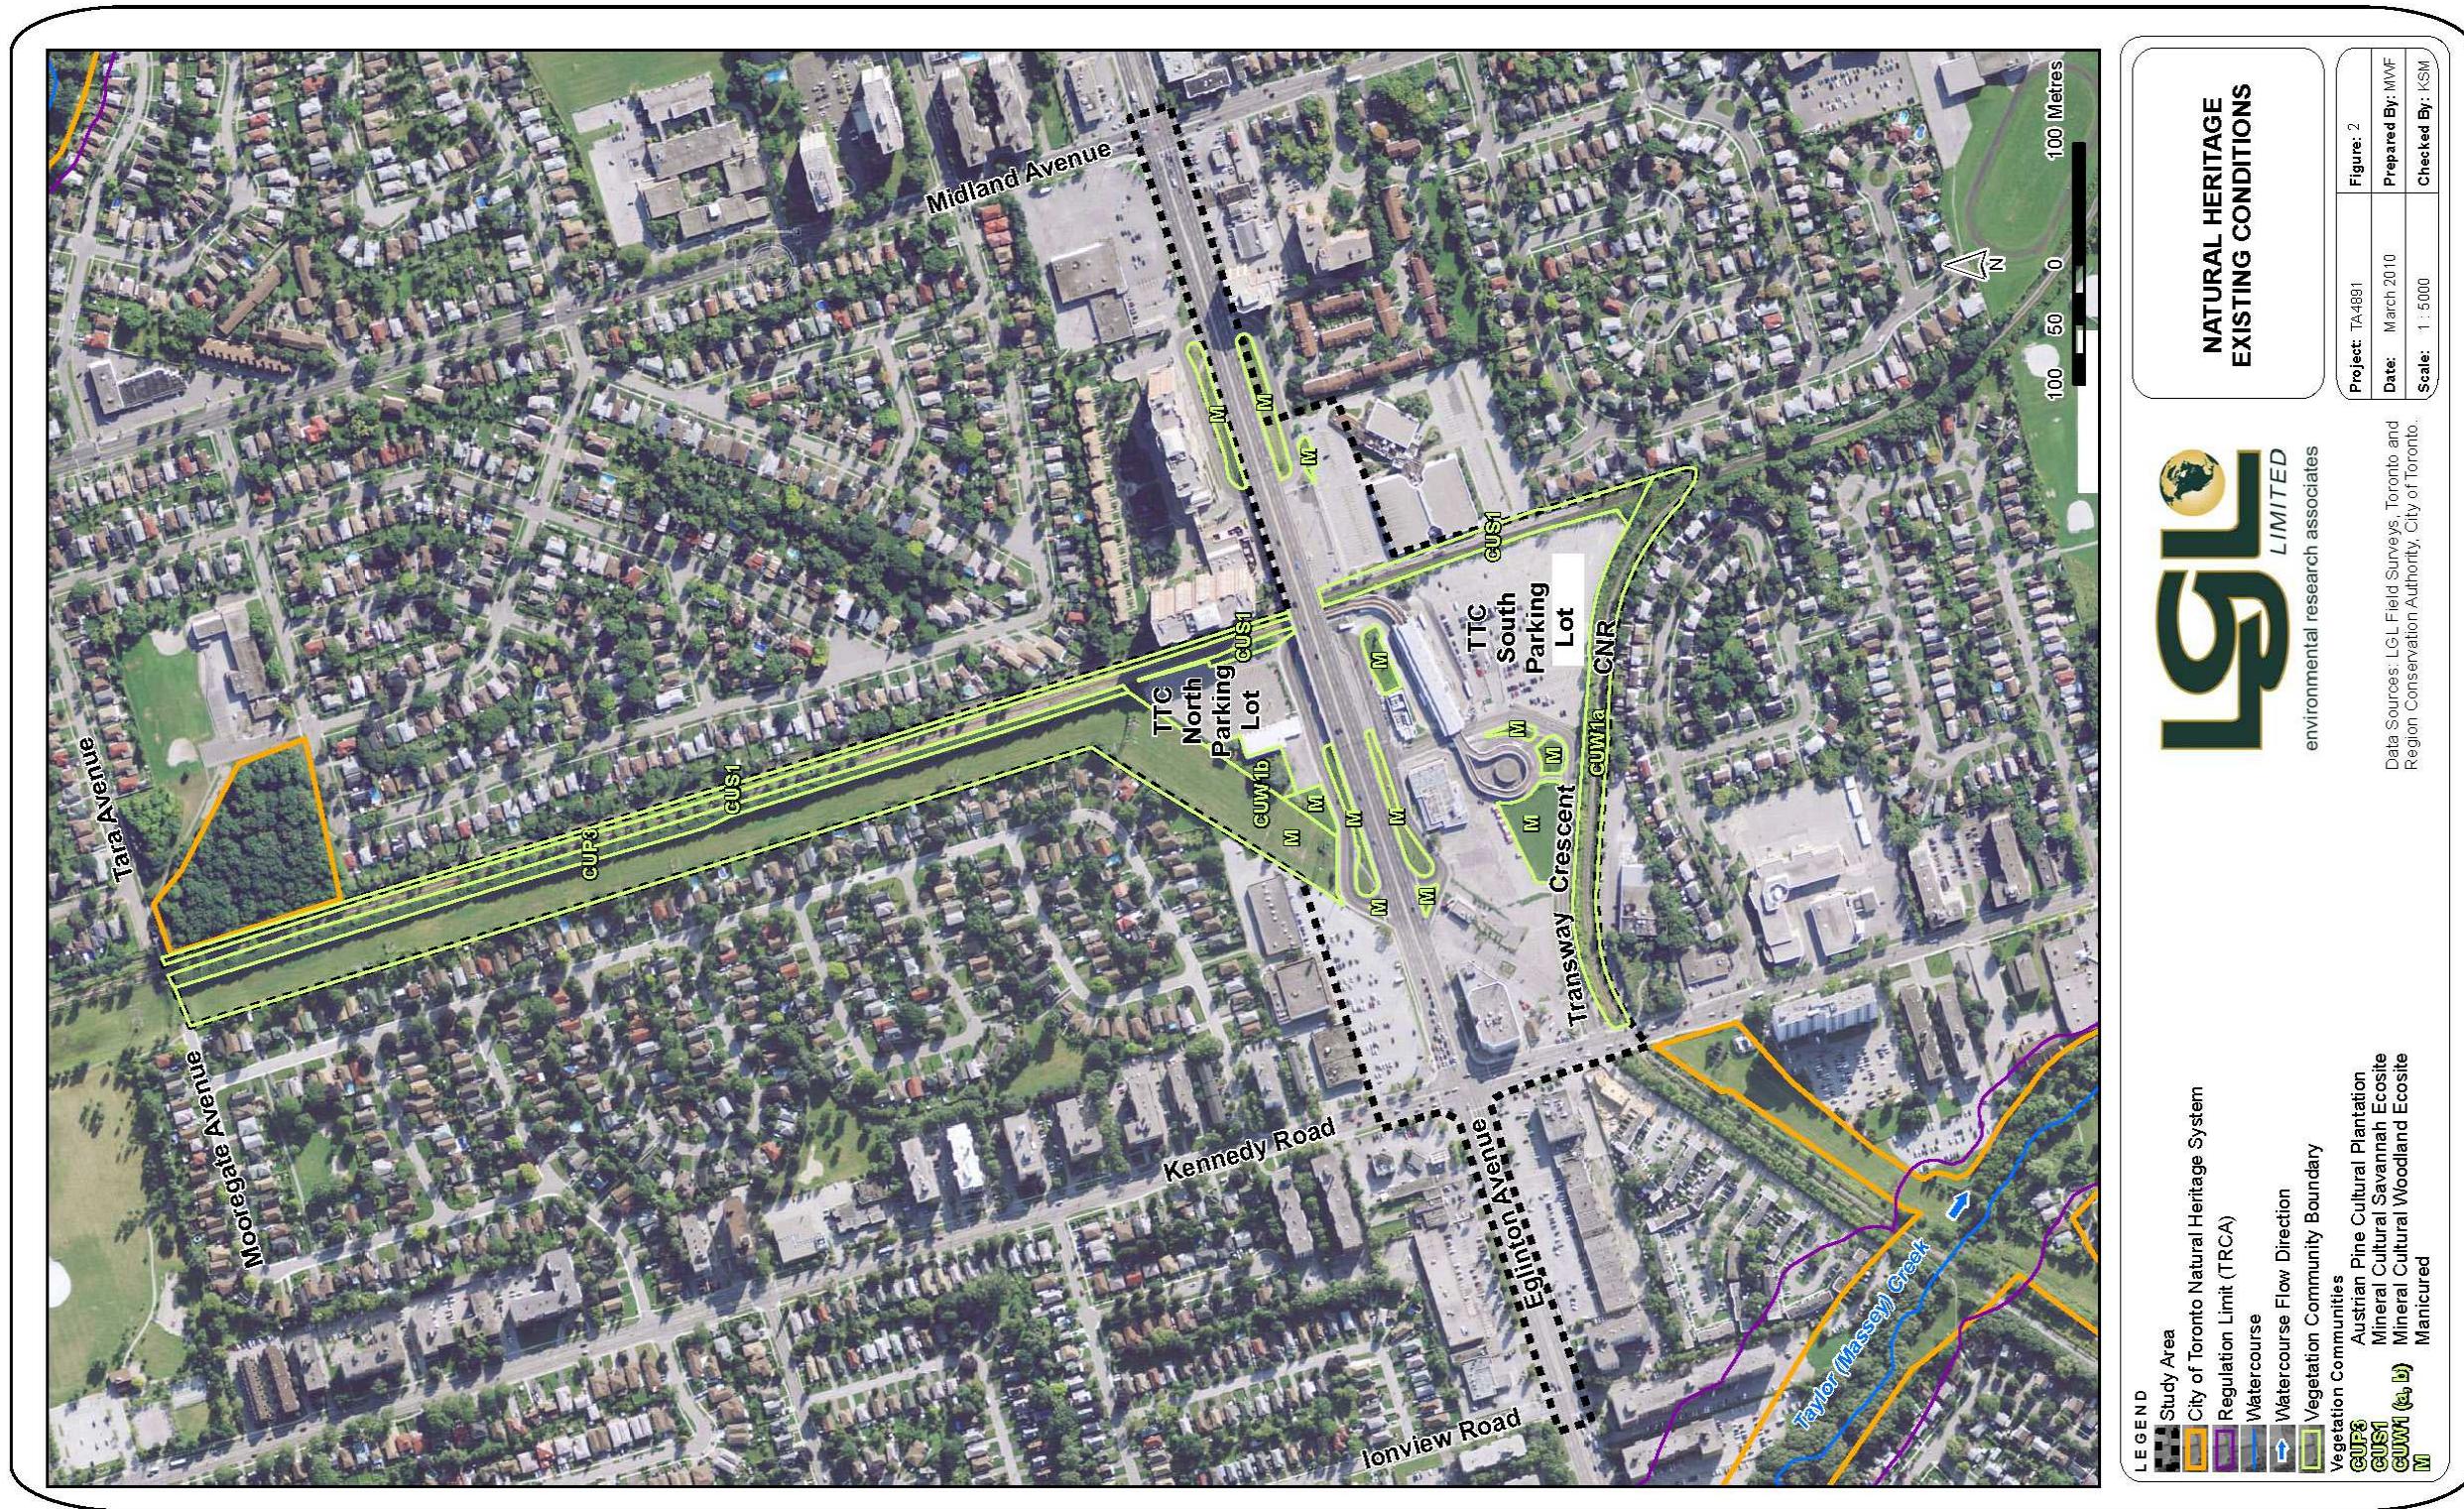
Exhibit 3-2: Vegetative Communities surrounding Kennedy Station

The cultural plantation (CUP3) is a linear vegetation community and is located west of, and parallel to, the existing SRT corridor. It extends from the TTC North Service Road Parking Lot, north to the pedestrian overpass that connects Mooregate Avenue (west side of corridor) to Tara Avenue (east side of corridor).

There are two cultural woodland communities located within the study area. The first community (CUW1a) extends along the most southern boundary of the study area adjacent to Transway Crescent. The

vegetation community is found on both sides of the CNR/GO corridor but it is separated from Transway Crescent by a chain link fence. The cultural woodland community (CUW1b) is located adjacent to the hydro corridor on the western edge of the North TTC Parking Lot.

The cultural savannah (CUS1) community runs alongside the CNR/GO on the east and west sides, north and south of Eglinton Avenue. These vegetation communities are delineated on Exhibit 3-2.

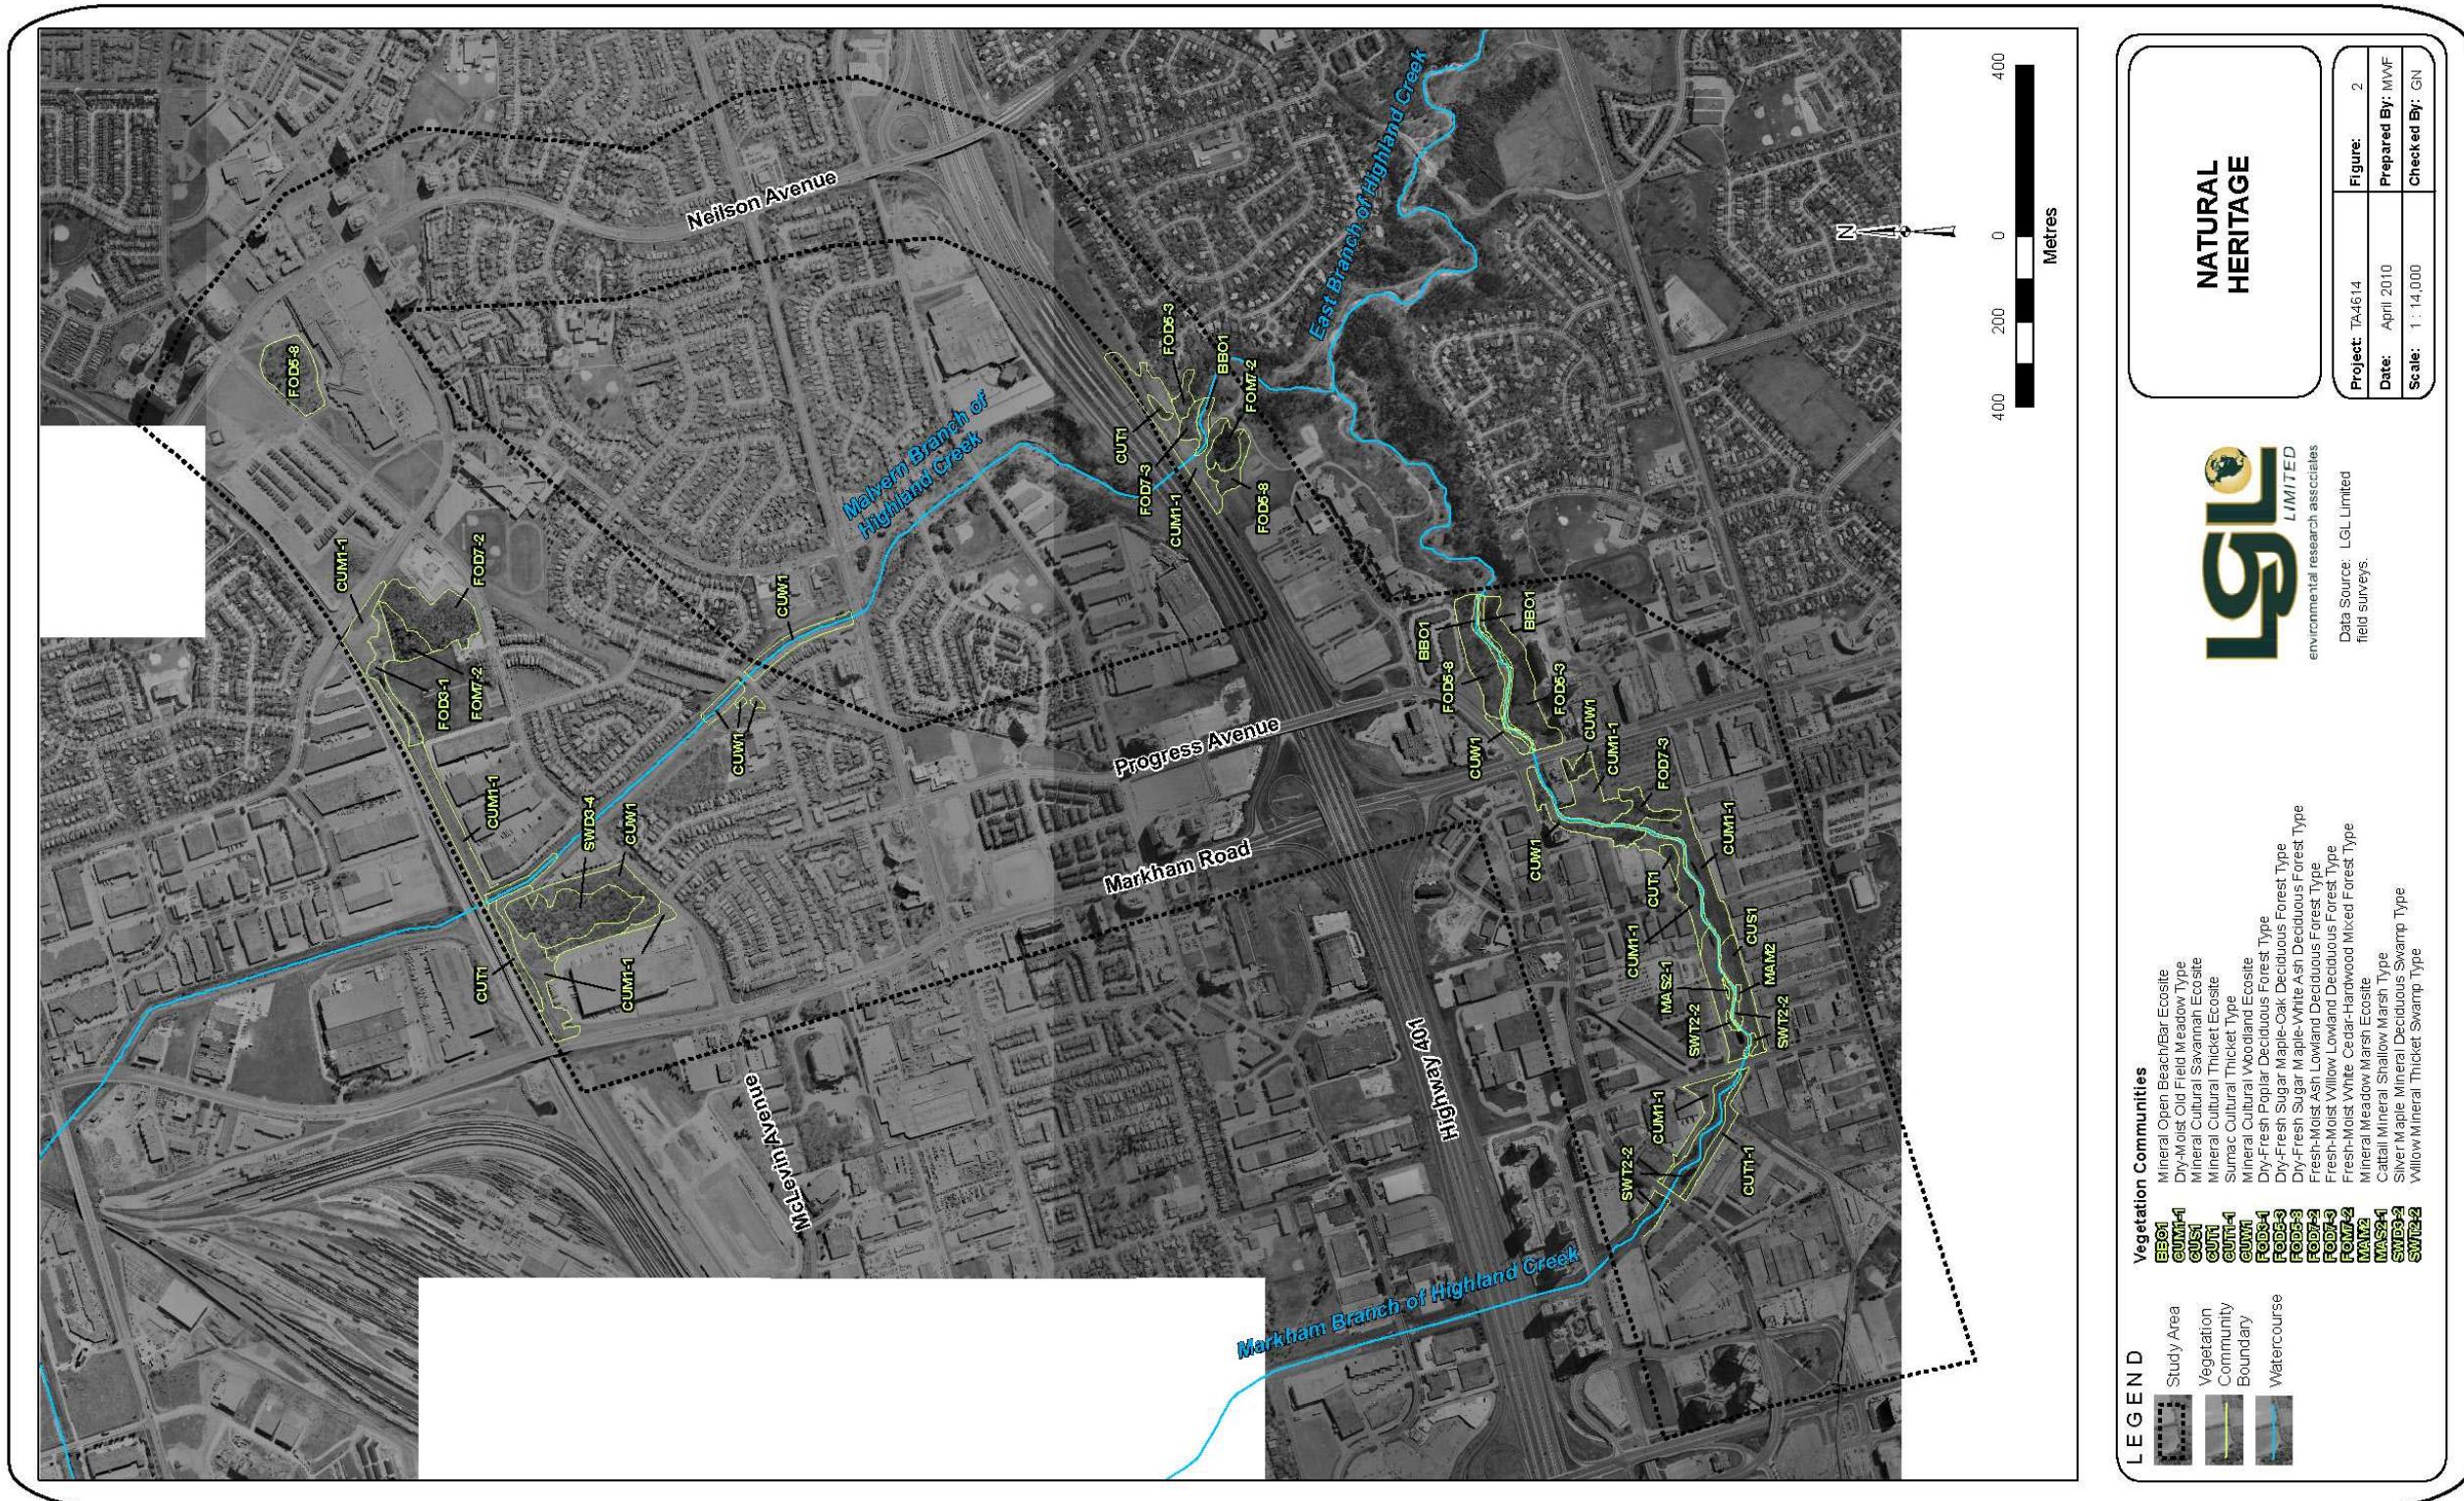
Exhibit 3-3: Vegetative Communities within the Extension Study Area

As identified in Exhibit 3-3, a total of sixteen ELC community types have been identified by LGL Limited within the study limits. These communities include: open beach/bar (BB01); mixed forest (FOM7-2); deciduous forests (FOD3-1, FOD5-3, FOD5-8, FOD7-2 and FOD7-3); cultural meadow (CUM1-1); cultural thickets (CUT1 and CUT1-1); cultural savannah (CUS1); cultural woodland (CUW1); deciduous swamp (SWD3-4); thicket swamp (SWT2-2), meadow marsh (MAM2-2) and shallow marsh (MAS2-1). BBO1 vegetation community is designated L3, which means that this community is of regional concern; restricted in occurrence and/or requires specific site conditions; generally occurs in natural rather than cultural areas.

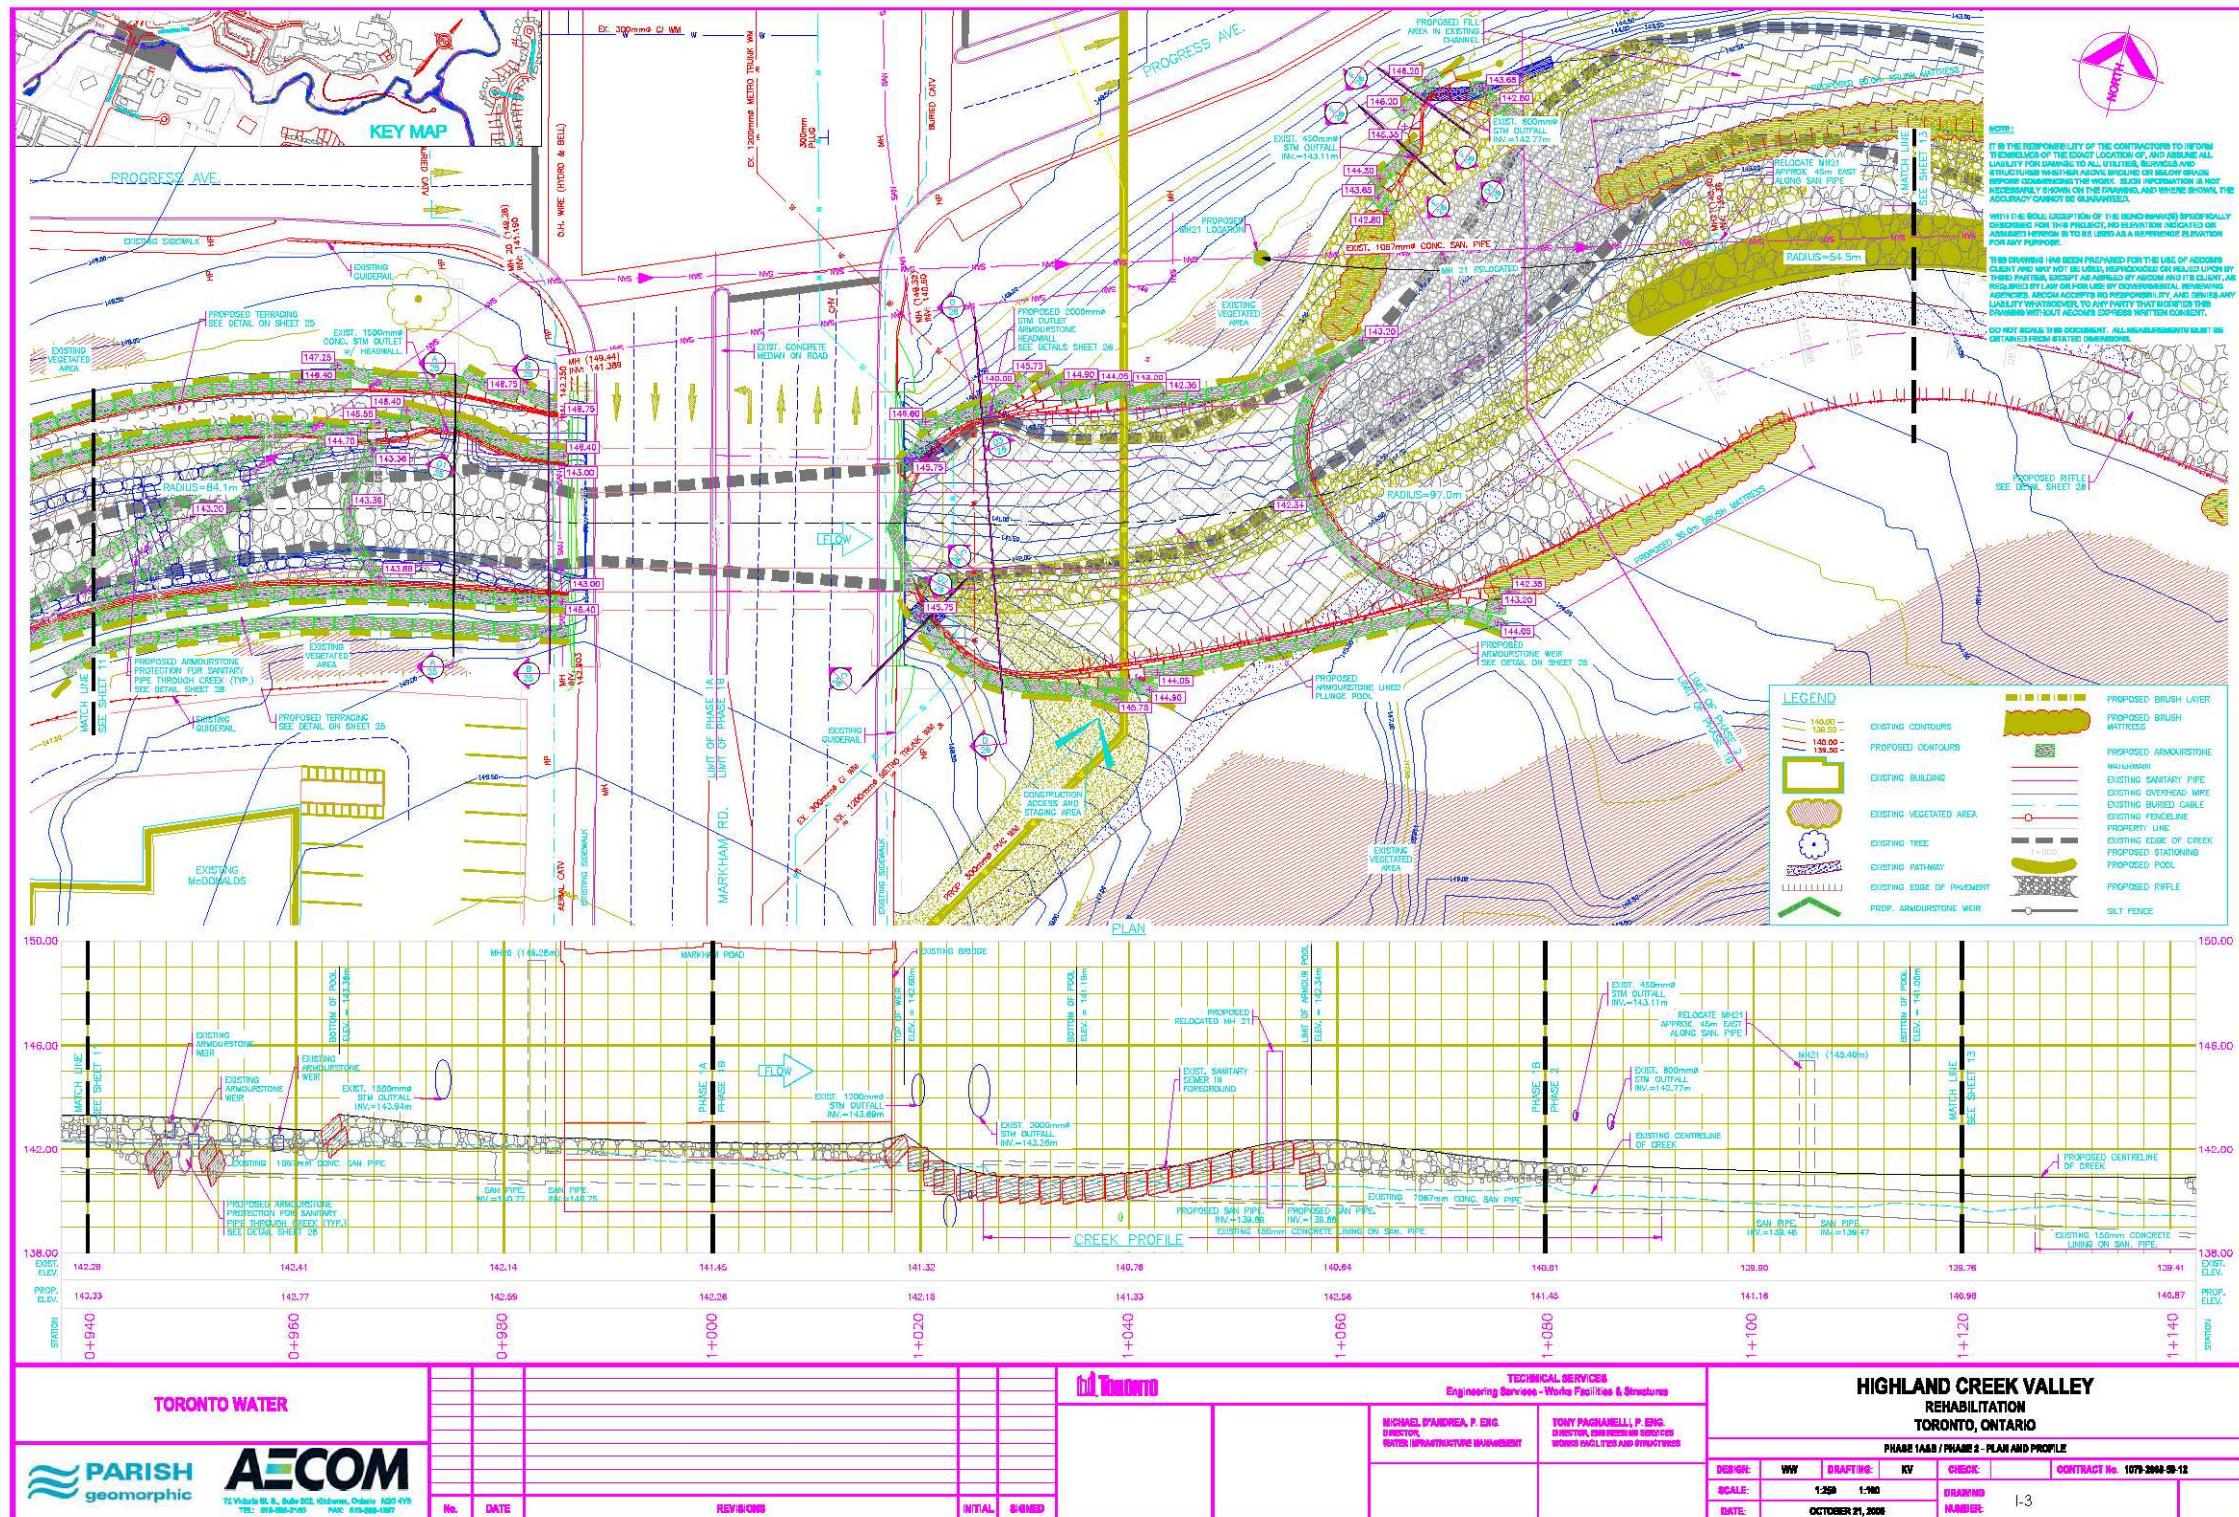
Exhibit 3-4: Proposed Toronto Water Stream Works in the vicinity of Markham Road

Remedial works within the Highland Creek subwatershed is ongoing. The Highland Creek segment 4/4a Class Environmental Assessment Study began in 2005 and the focus has been on the valley segment that extends from upstream of Markham Road to the Malvern Branch of Highland Creek. Now in the detailed design stage, Toronto Water will be undertaking extensive restoration works, which will include creek realignment (Exhibit 3-4) and the enhancement of habitat through the introduction of riffle pools and other features. Vegetation in the area that must be removed to facilitate the works will be replaced. The SRT extension has been planned in concert with these plans.

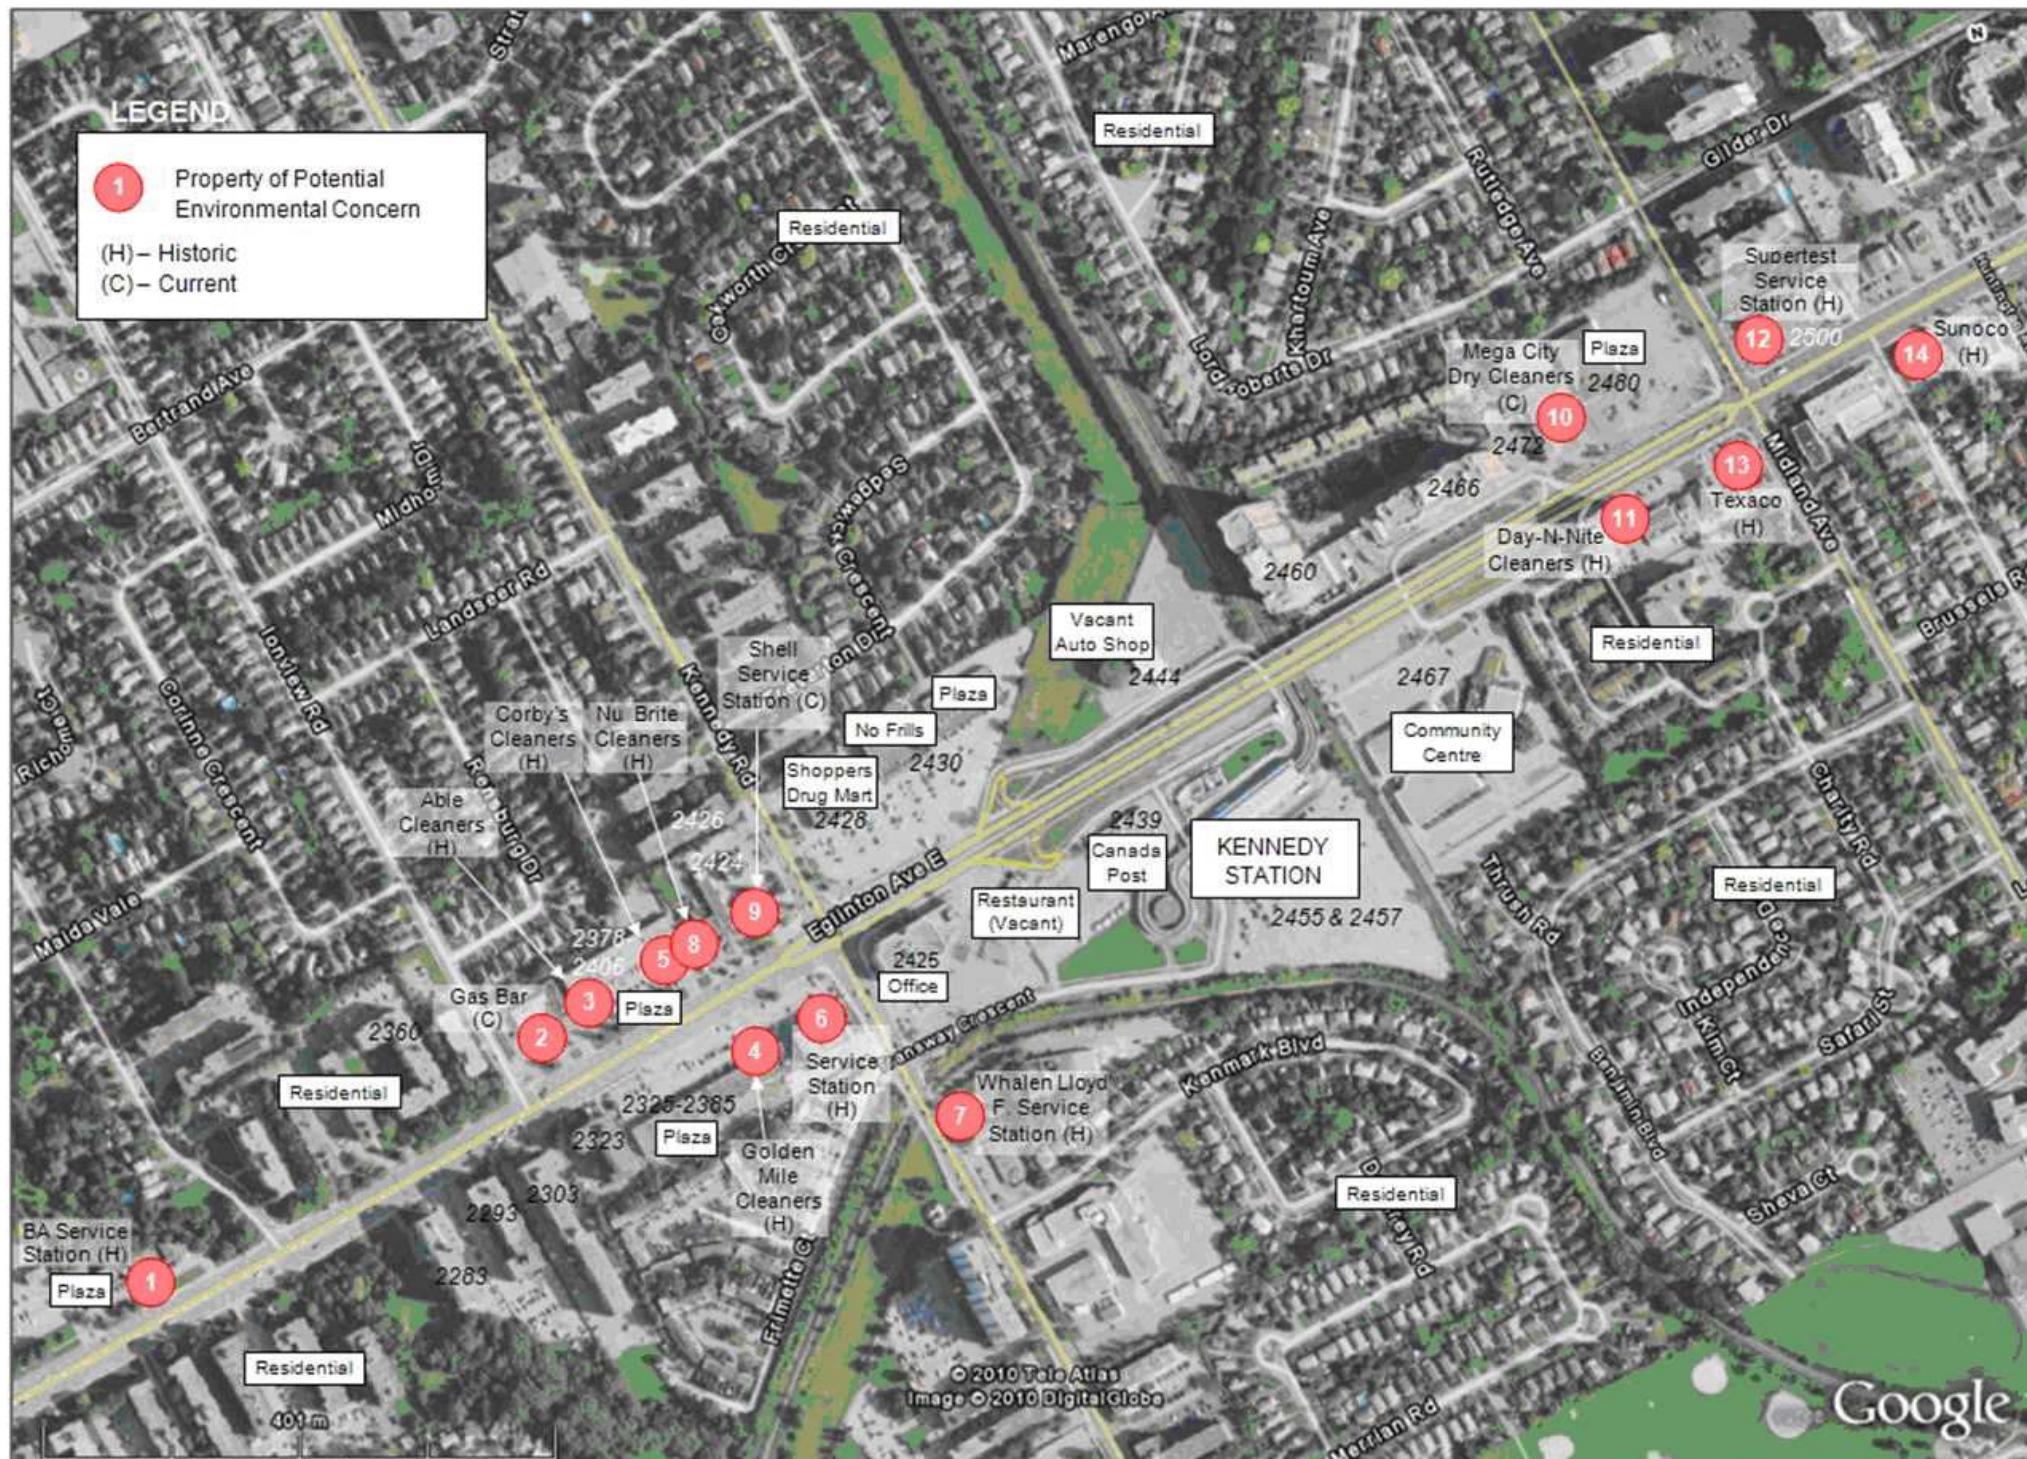
Exhibit 3-5: Sites in the vicinity of Kennedy Station with High Potential Environmental Concerns

Several potential environmental concerns were identified in the Extended Study Area. Historical records indicated that numerous service stations and dry cleaners were present along Eglinton Avenue East and Kennedy Road within the Extended Study Area since at least 1960. The following table presents the fourteen (14) properties of potential environmental concern identified in the Extended Study Area. The key criteria used to assess environmental records in order to select the properties with the highest potential environmental concern were: spill history; operational history (i.e. type and length of historical land use); and current operations. The locations of the properties with highest potential environmental concern are presented for reference on Table 3-2 and Exhibit 3-5.

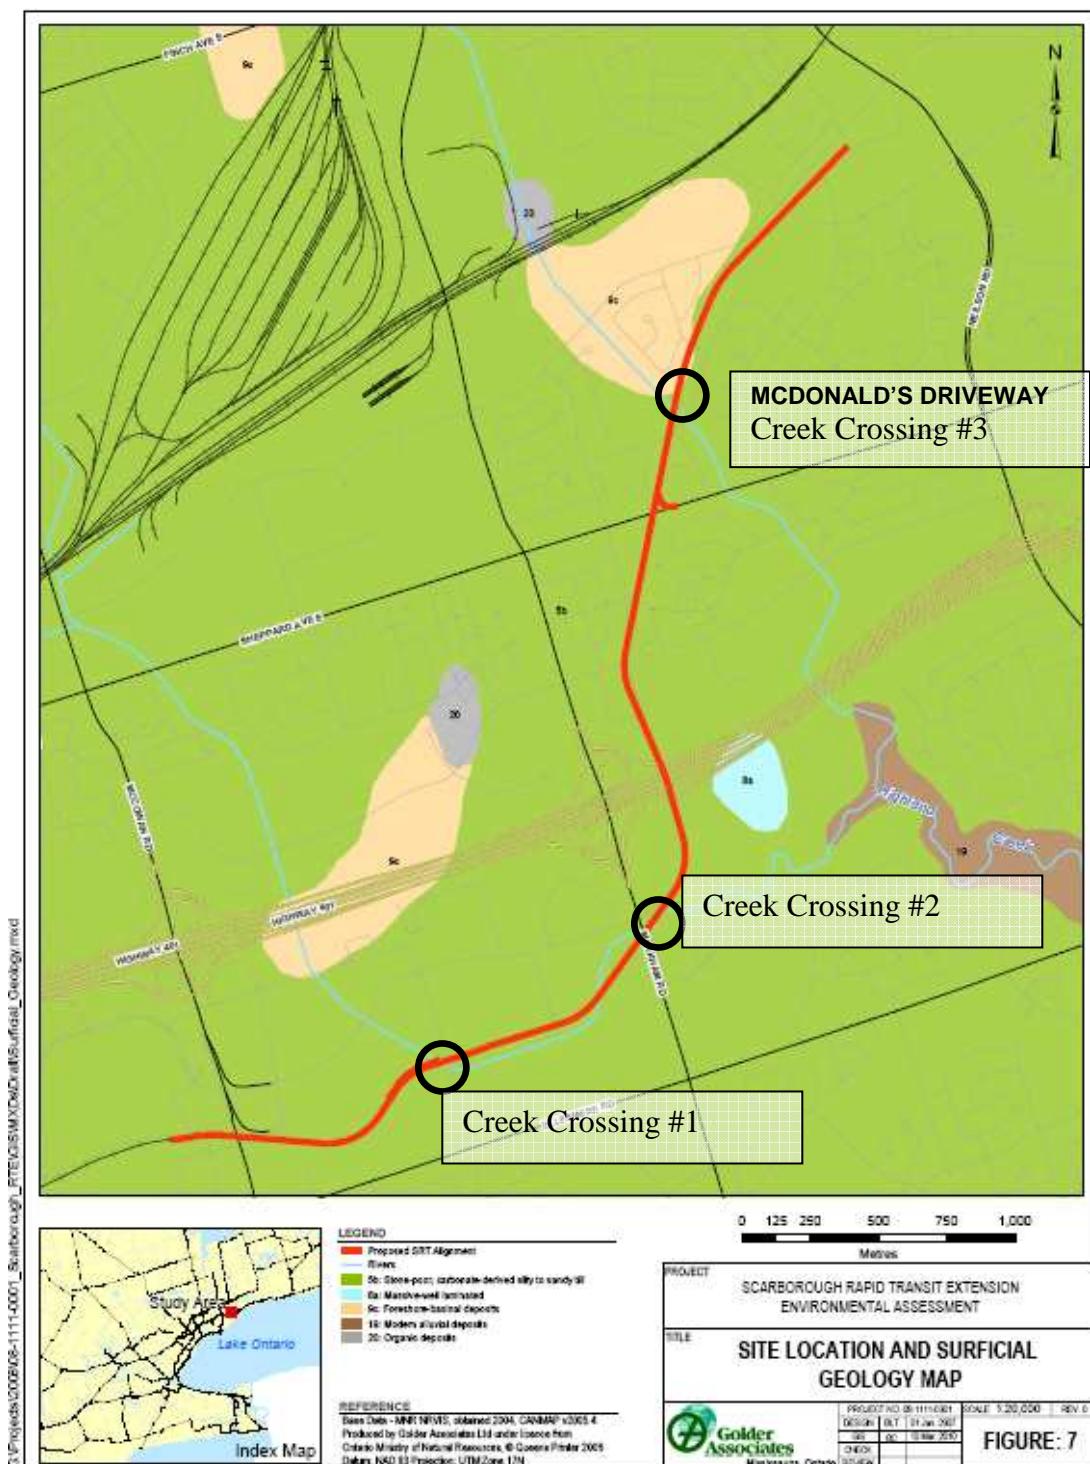
Exhibit 3-6: Surficial Geology Map

The Quaternary deposits of the Toronto region consist predominantly of glacial till, glaciolacustrine and glaciofluvial sand, silt, and clay deposits and beach sands and gravels. These deposits were laid down by glaciers and associated glacial rivers and lakes. Recent deposits of alluvium are found in river and stream valleys and their flood plains. The Quaternary soil deposits overlie the bedrock of the Georgian Bay Formation which consists predominantly of shale with interbeds of limestone and siltstone. This bedrock is generally found in the study area at between Elevations 80 and 60 m. A surficial geology map of the study area is shown on Exhibit 3-6.

As illustrated in Exhibit 3-6 the proposed SRT alignment crosses two tributaries of Highland Creek; crossing one tributary three times in the southwest section and crossing the second tributary once in the northern section of the proposed alignment.

The first crossing in the southwest section is about half of distance along Bellamy Road between Progress Avenue and Ellesmere Road. The second crossing is a short distance west of Markham Road between Progress Avenue and Ellesmere Road and the third crossing is at the south west corner of Markham Road and Progress Avenue intersection. In the northern portion of the proposed SRT alignment, the crossing of the Highland Creek is a short distance north of Mammoth Hall Trail (north of Sheppard Avenue East).
