## APPENDIX C2 – MEANDER BELT ANALYSIS

DATE: November 28<sup>th</sup> 2008

SUBJECT: Highland Creek Meander Belt Width Assessment – Morningside Avenue

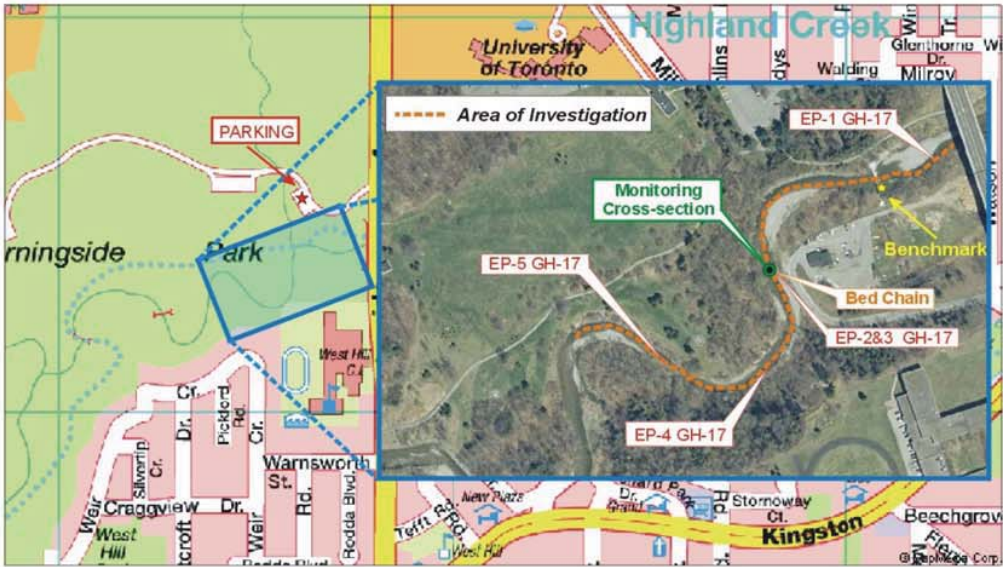
As part of a Regional Monitoring Program undertaken by PARISH Geomorphic Ltd. on behalf of Toronto and Region Conservation Authority (TRCA) a long-term monitoring station was established on Highland Creek upstream of Morningside Avenue in 2003 (**Figure 3**). Monitoring efforts at the site included a control cross-section, erosion pins, and bed chain. At the time of establishment, a full detailed field investigation was also completed, including a long profile survey.

**Figure 3.** Extent of detailed field site established through TRCA Regional Monitoring Program.

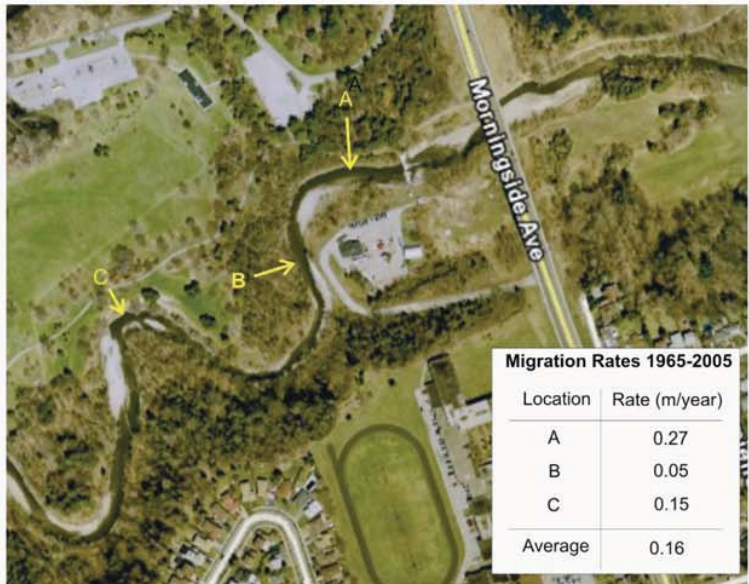
Following the historical assessment, the aerial photographs from 1965, 1978, and 2005 were used to determine migration rates for the calculation of the 100-year erosion rate. Migration rates quantify the rate at which a meander bend of a stream moves across its valley, and are used to help predict future channel shifts. The 100-year erosion rate is therefore the distance the bank will erode over a 100 year period. Measurements are generally taken from a benchmark that is consistent within each aerial photograph, to the outer extent of a meander bend. Migration rates were calculated for several meanders and averaged to yield an average rate of 0.16 m/year for points upstream of Morningside Avenue (**Figure 6**).

Figure 6. Locations of migration rate calculations on Highland Creek.
